ACR No. 4C31

EXPERIMENTAL STUDY OF THE COATING FORMED ON NITRIDED-STEEL
PISTON RINGS DURING OPERATION IN NITRIDED-STEEL CYLINDERS

By A. R. Bobrowsky, J. Howard Kittel, and Charles P. Boegli

Aircraft Engine Research Laboratory
Cleveland, Ohio

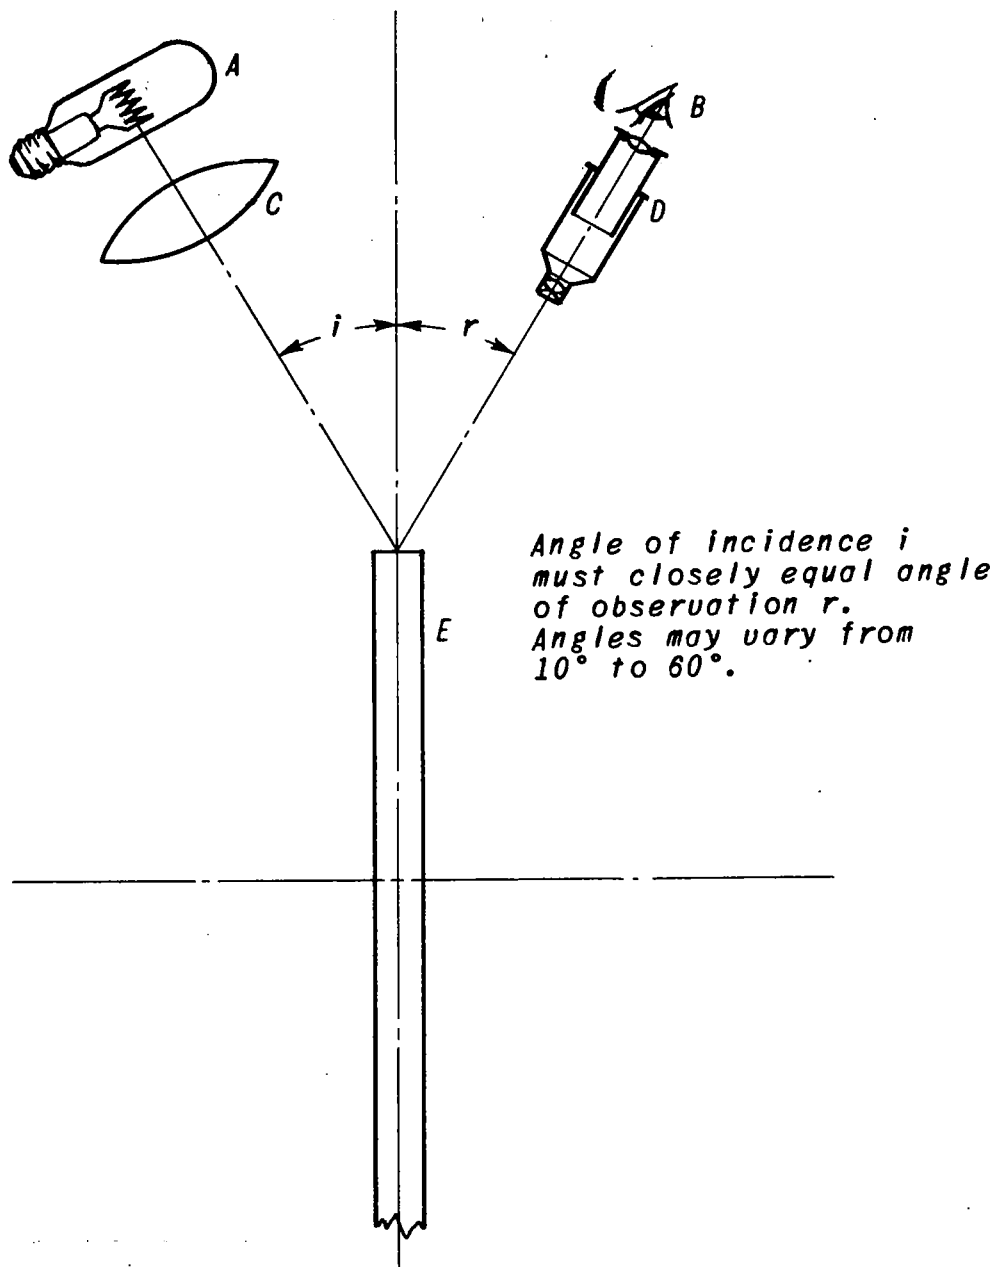
A Light source
B Observer or camera
C Condensing lens

D Microscope
E Piston-ring specimen

Figure 1. - Geometry of illuminating and viewing coating on a piston ring.

Although the coating in piston rings can be examined with vertical illumination, the setup illustrated in figure 1 was used for visual observation because of the greater ease of viewing. A metallurgical microscope was used for all plan-view photomicrographs at magnifications of from 40 to 70 diameters.

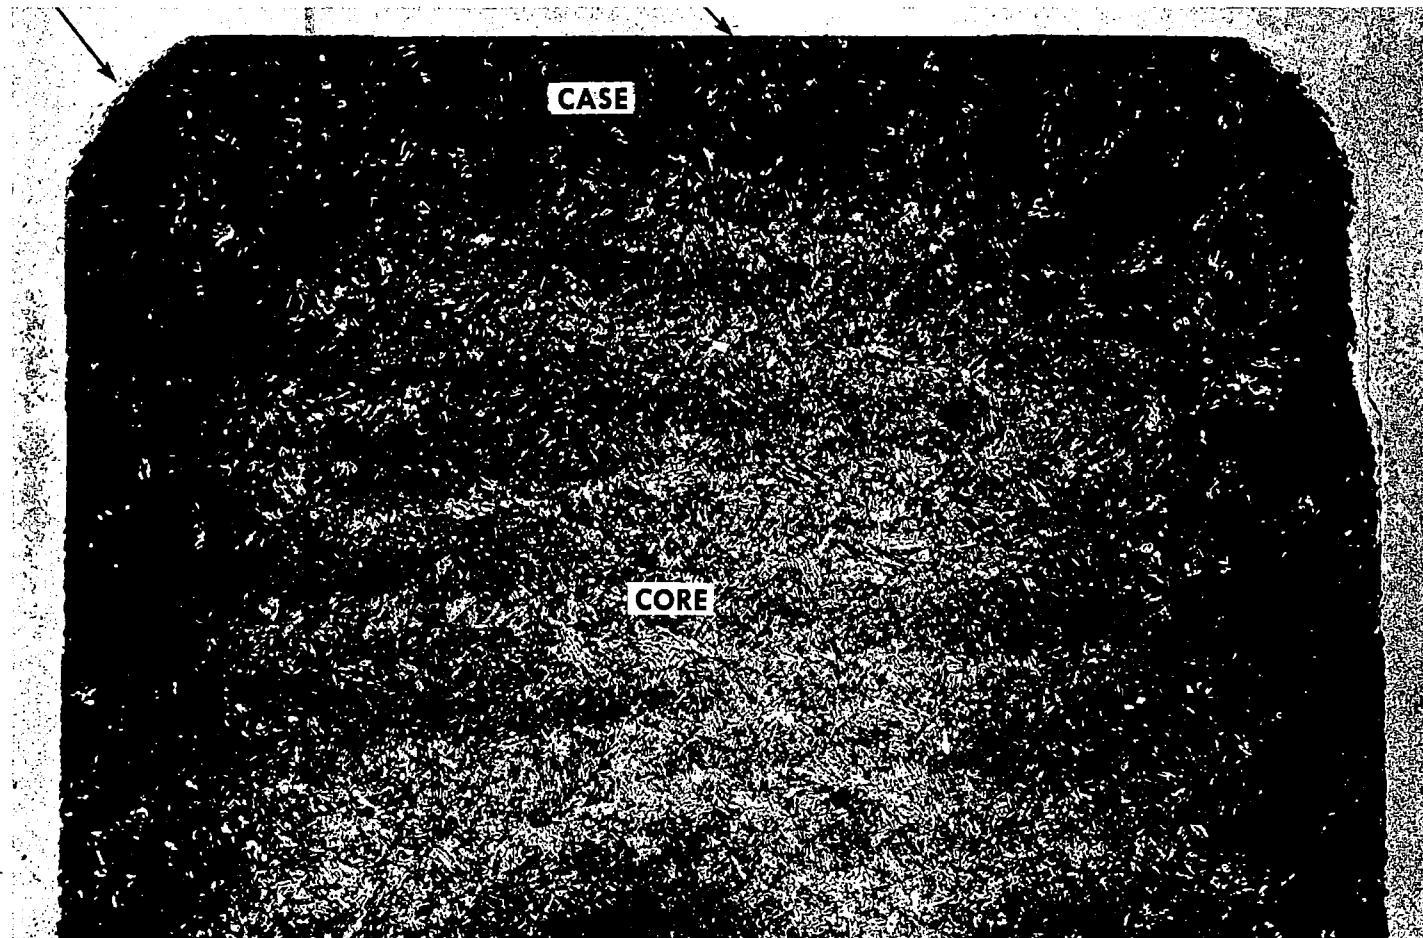
Fig. 2

WHITE NITRIDES

RUNNING FACE

CASE

CORE

Figure 2.—Transverse section of a typical nitrided-steel piston ring. The black spots in the core are inclusions. (Cf. fig. 6.) The white nitrides are present at the corners of the ring where they have not been removed by machining. Etched in nital. $\times 100$.

Photomicrographs of nitrided-steel piston rings are presented for convenience of reference. Figure 2 illustrates the cross section of a typical nitrided-steel piston ring. The polished and etched cross section shows the unnitrided core, the thick, dark-appearing nitrided case, and the thin shell of "white" nitrides. The entire ring is covered with white nitrides immediately after nitriding, but the white layer is subsequently removed by machining except at the corners. Figures 3, 4, and 5 are highly magnified details of the core, the case, and the white edge, respectively. The isolated dark spots shown in figure 2 are inclusions in the original unnitrided steel as may be seen from figure 6, which is a photomicrograph of an unetched polished cross section. All specimens intended for cross-sectional observation were plated with nickel before polishing in order to back up the surface profile and prevent rounding of the specimen edges during the polishing operation.

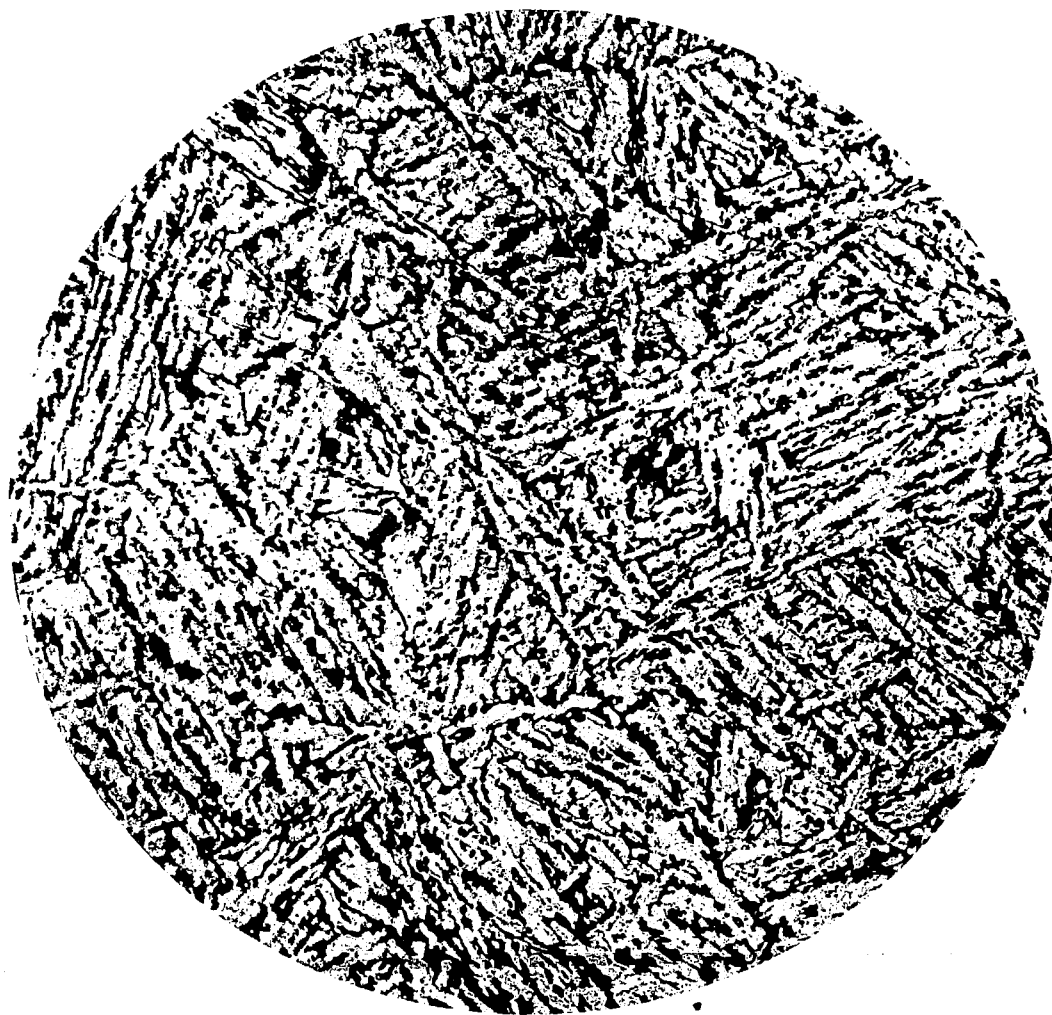
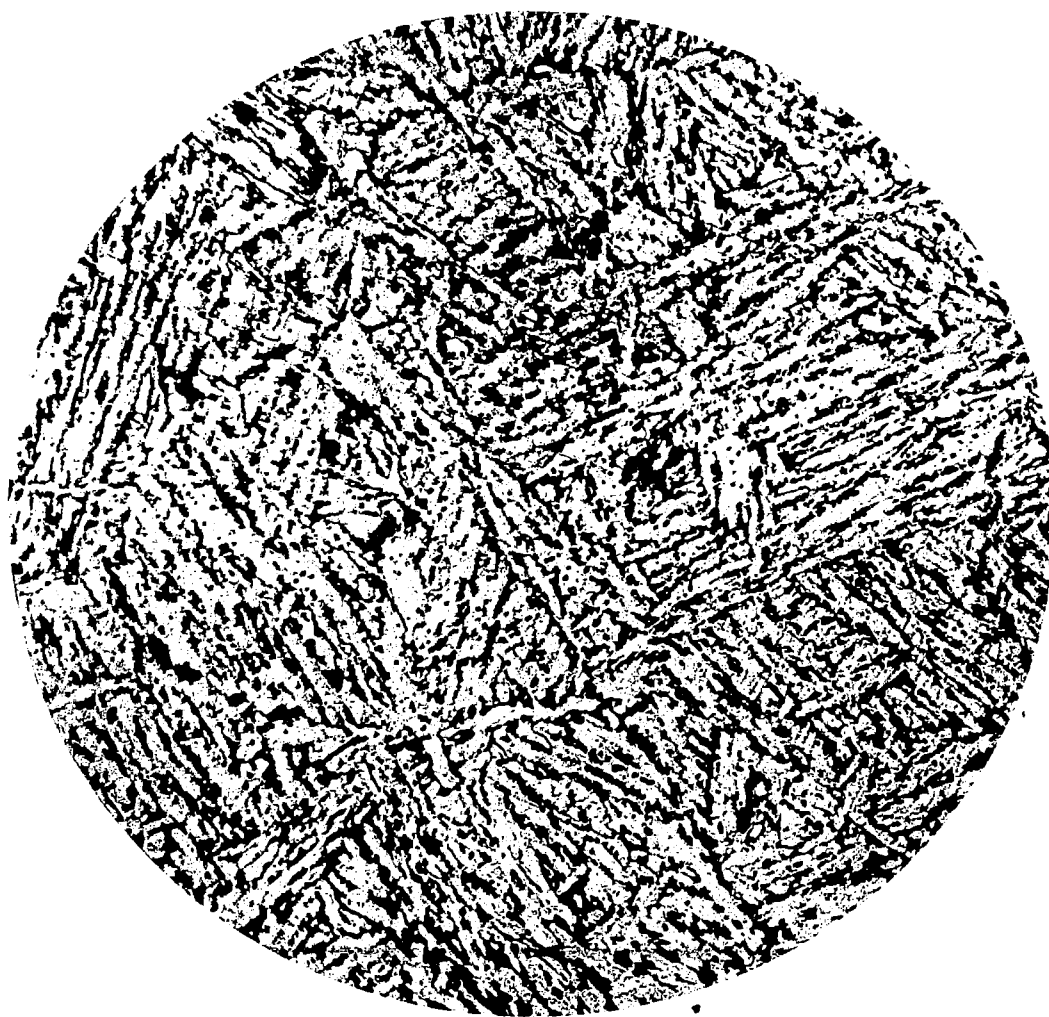
Figure 3.—Core structure of a typical nitrided-steel piston ring. Etched in nital. $\times 1,500$.

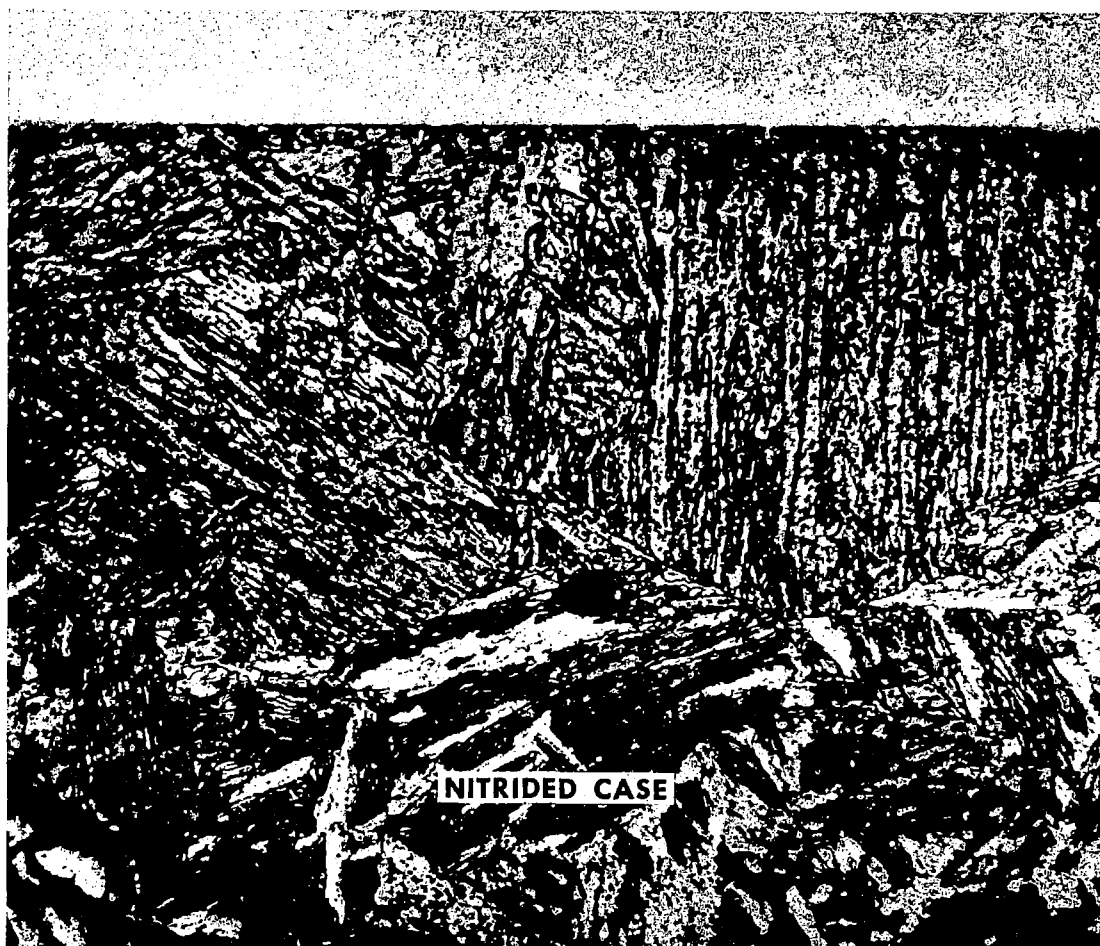
Figure 4.—Transverse section of the running face of a nitrided-steel piston ring after test that has not developed coating material. The grain structure is undeformed up to the surface of the ring. This undeformed material is characteristic of those areas where coating material has not been formed. Etched in nital. $\times 1,500$.

The metallurgical changes observed where coating material had formed in the running faces of nitrided-steel piston rings were two-fold; a coating layer was created, and the metal grains just beneath were deformed. A typical cross section of a portion of the running face of a nitrided ring on which no coating has been formed is shown in figure 4. In this ring the grains are undeformed. Figure 14 shows the deformed (worked) grain structure of a portion of a ring face in which a coating has formed. The individual grains apparently retain their identity up to the point of conversion to coating material, even when the elongated grains no longer resemble any part of the original structure. Figures 12 and 13 show another portion of a piston-ring face, but here the grains lose their identity and merge to form a nearly homogeneous layer directly beneath the coating material.

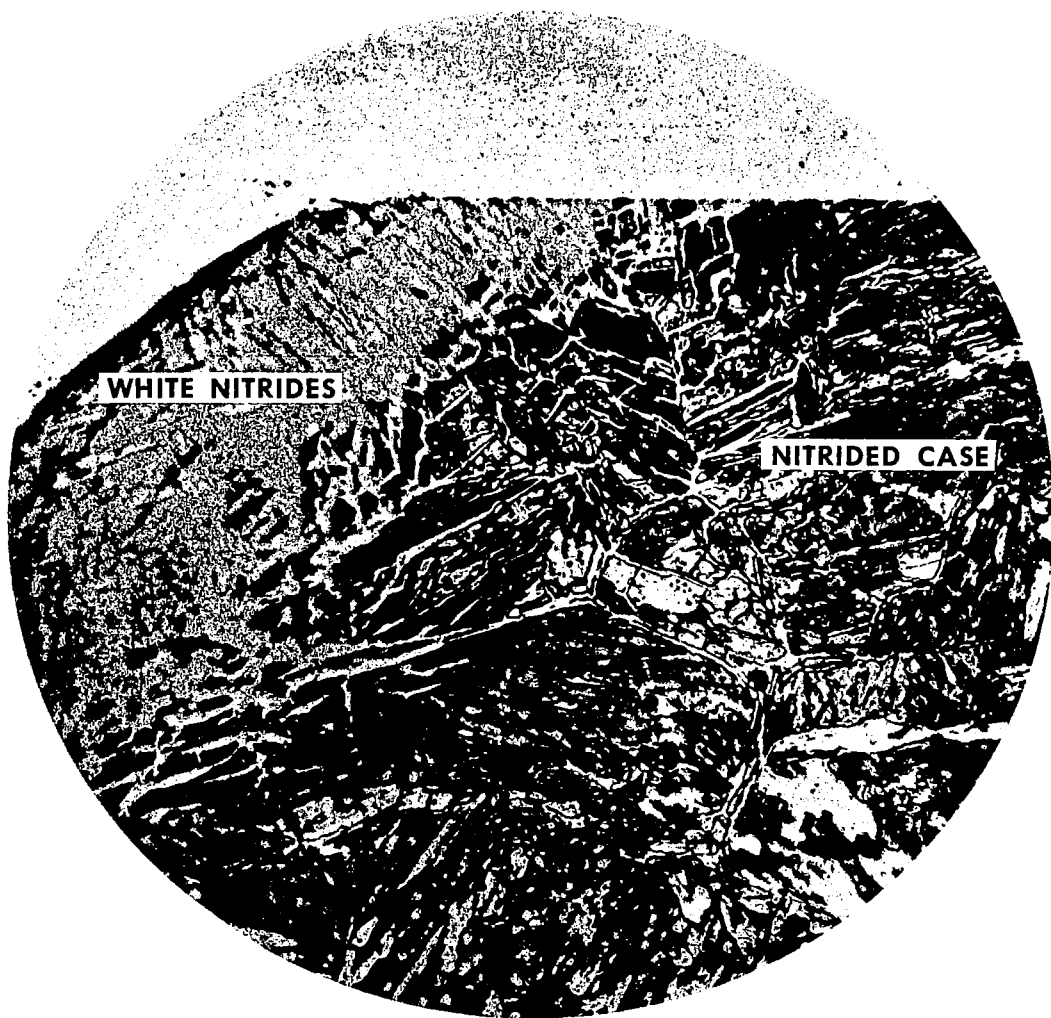
Figure 5.—Transverse section of the upper edge of the running face of a typical nitrided-steel piston ring. The white nitrides are present at the edges of the ring where they have not been machined off. Etched in nital. $\times 1,500$.

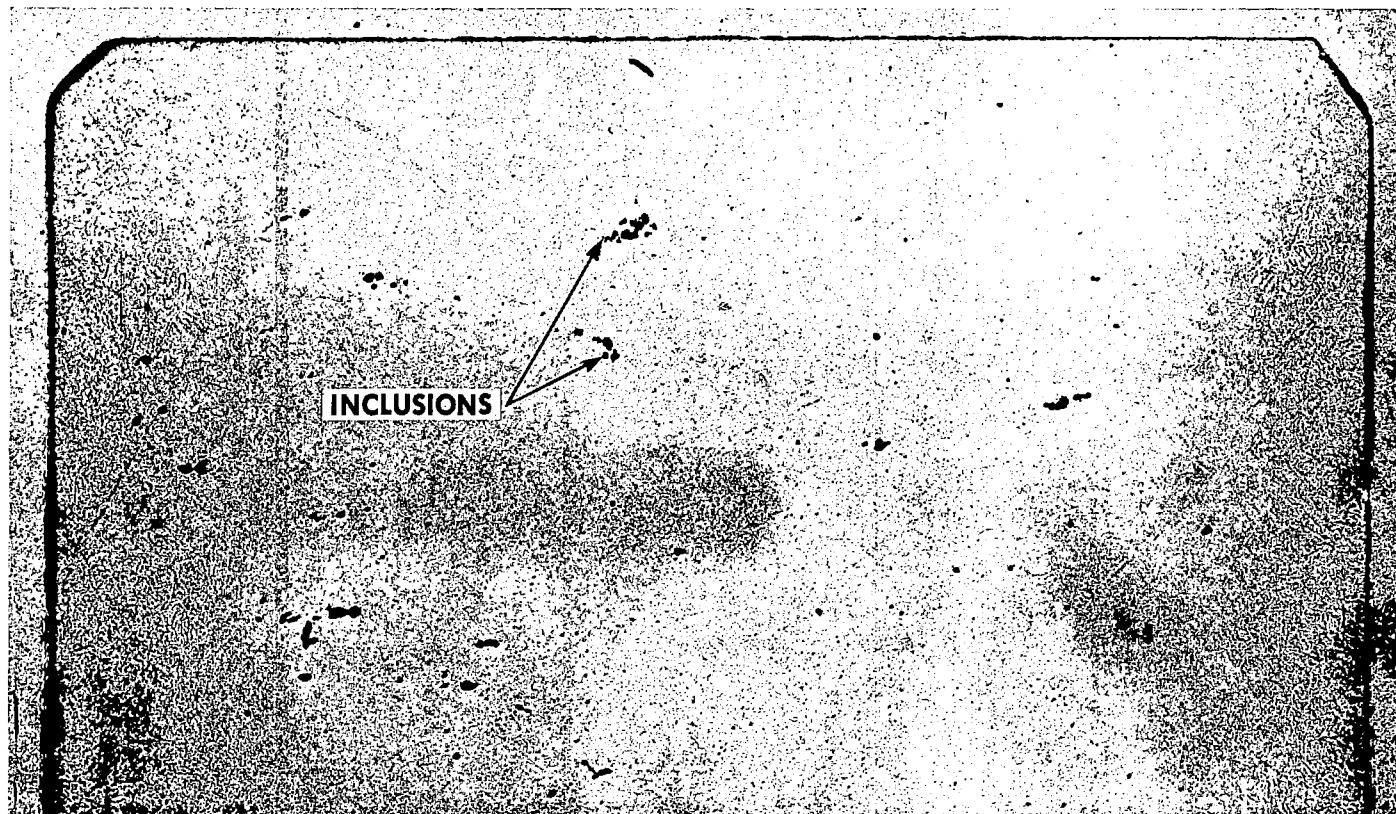
Figure 6.—Transverse section of a typical nitrided-steel piston ring showing inclusions. Unetched. $\times 100$.

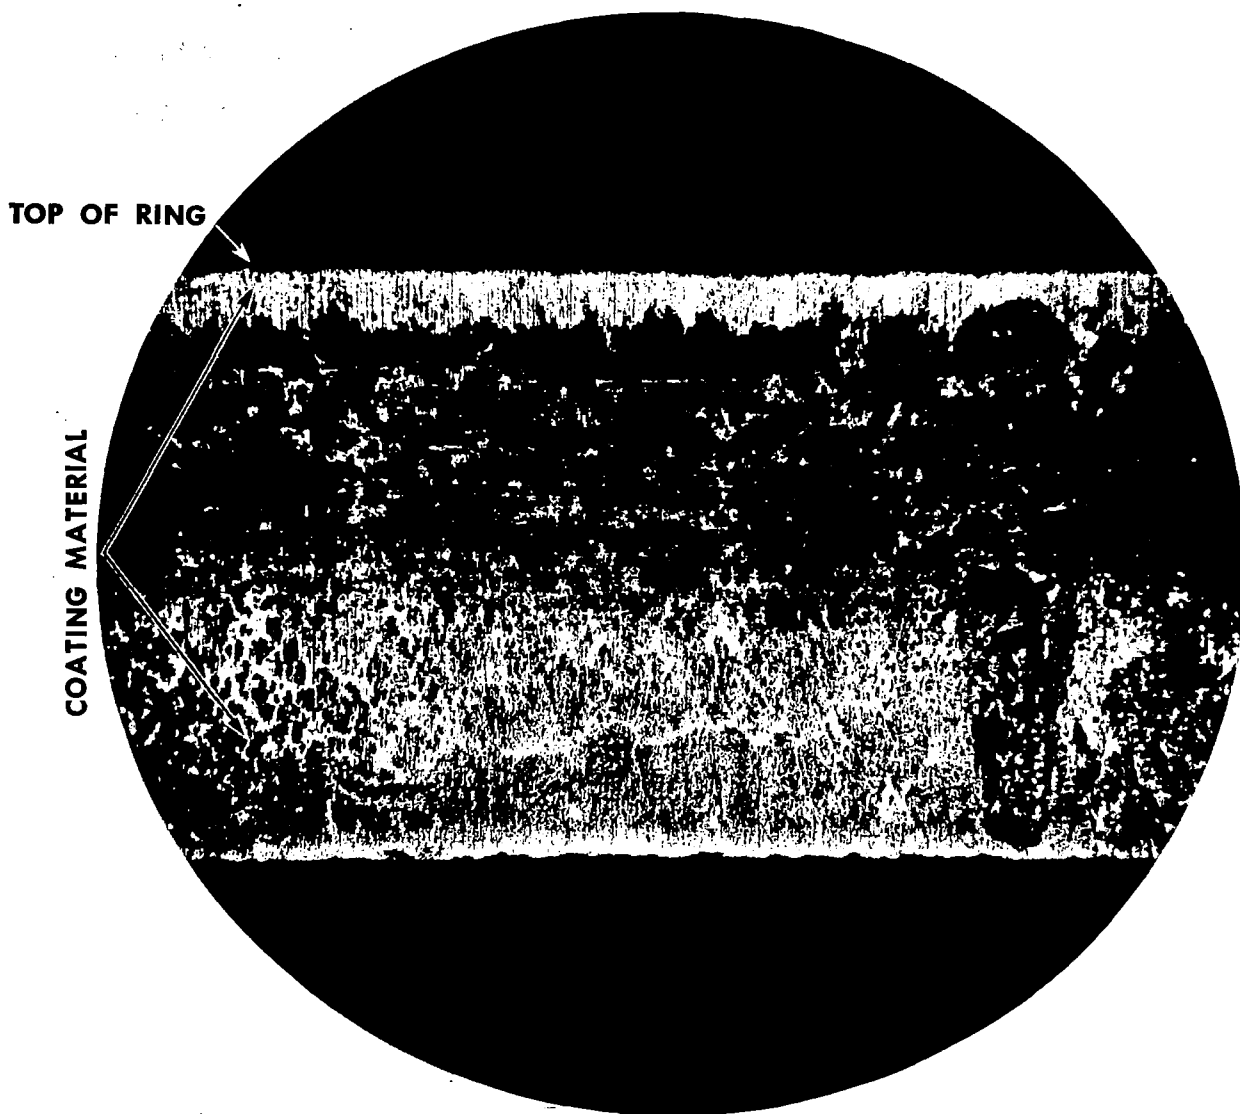
Figure 8.—Running face of a nitrided-steel piston ring after test, showing continuous occurrence of highly reflective material. Vertical illumination. This ring ran for 25 hours at 2,500 r. p. m. and a brake mean effective pressure of 209 pounds per square inch. Etched with dilute nitric acid. $\times 50$.

Observations of nitrided rings after operation indicated that the coating in a piston-ring face may occur in a mottled condition (fig. 7) or a relatively continuous condition (fig. 8). Inspection of many piston rings indicates that the rings which have operated the longest periods show a more nearly continuous appearance of coating than the rings which have operated for shorter periods. The running surface of the barrel appears to contain only small amounts of the coating. (See fig. 9.)

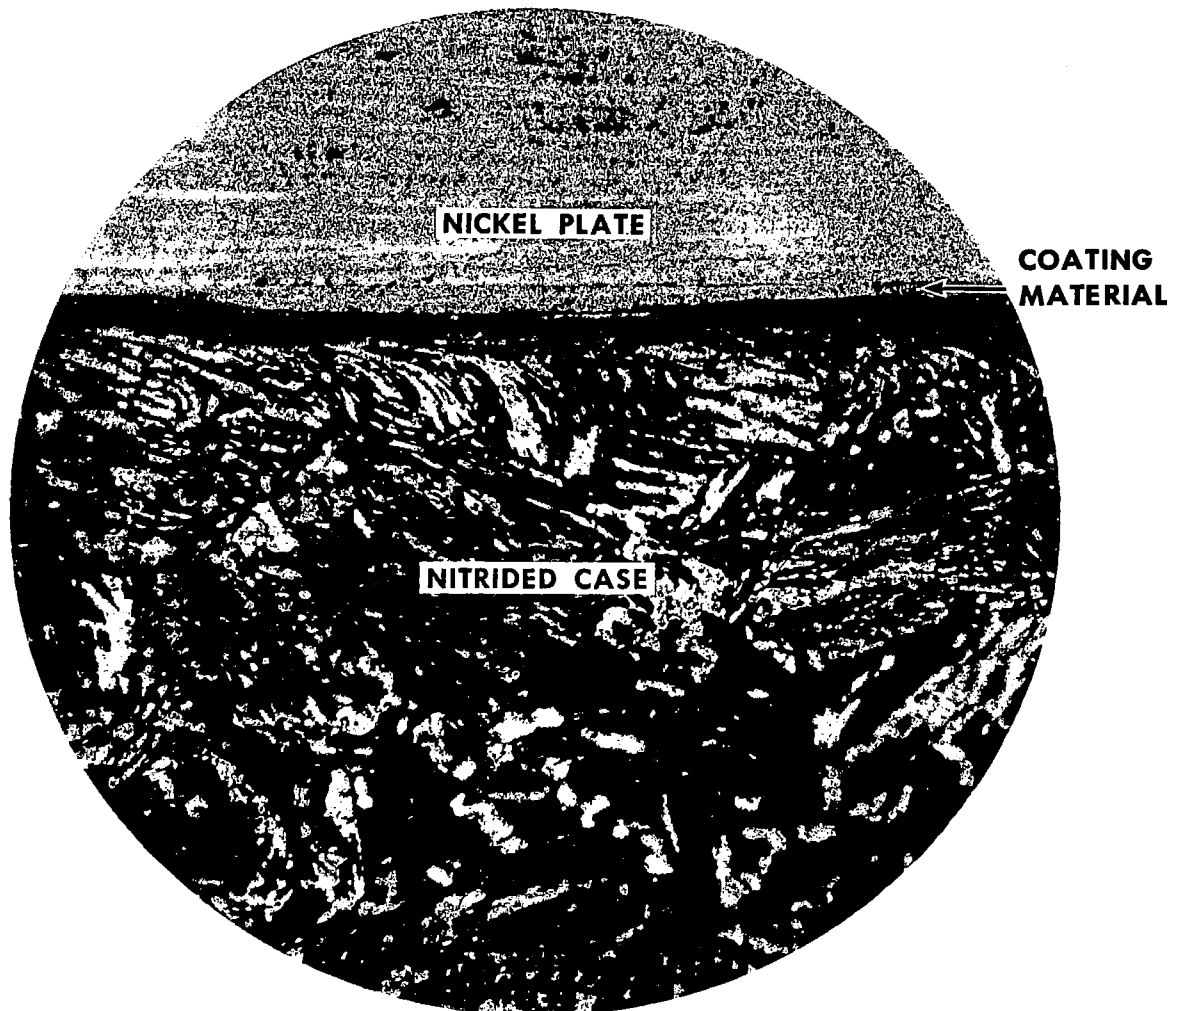
Figure 10.—Transverse section of the running face of a nitrided-steel piston ring after test, showing coating material. The coating material has not been etched and is therefore difficult to distinguish from the nickel layer directly above. Etched in nital. (Cf. fig. 11.) Same ring as figure 7. $\times 1,500$.

When a ring that contained coating material was sectioned, polished, and etched with the usual metallographic etching reagents for steel, such as 2 percent nital (nitric acid plus ethyl alcohol), the coating was difficult to observe. (See fig. 10.) When the same section was etched with potassium or sodium hydroxide, the coating material was attacked (fig. 11) and was clearly visible. No crystal structure was resolved in the coating layer even at the magnification of 1500 diameters.

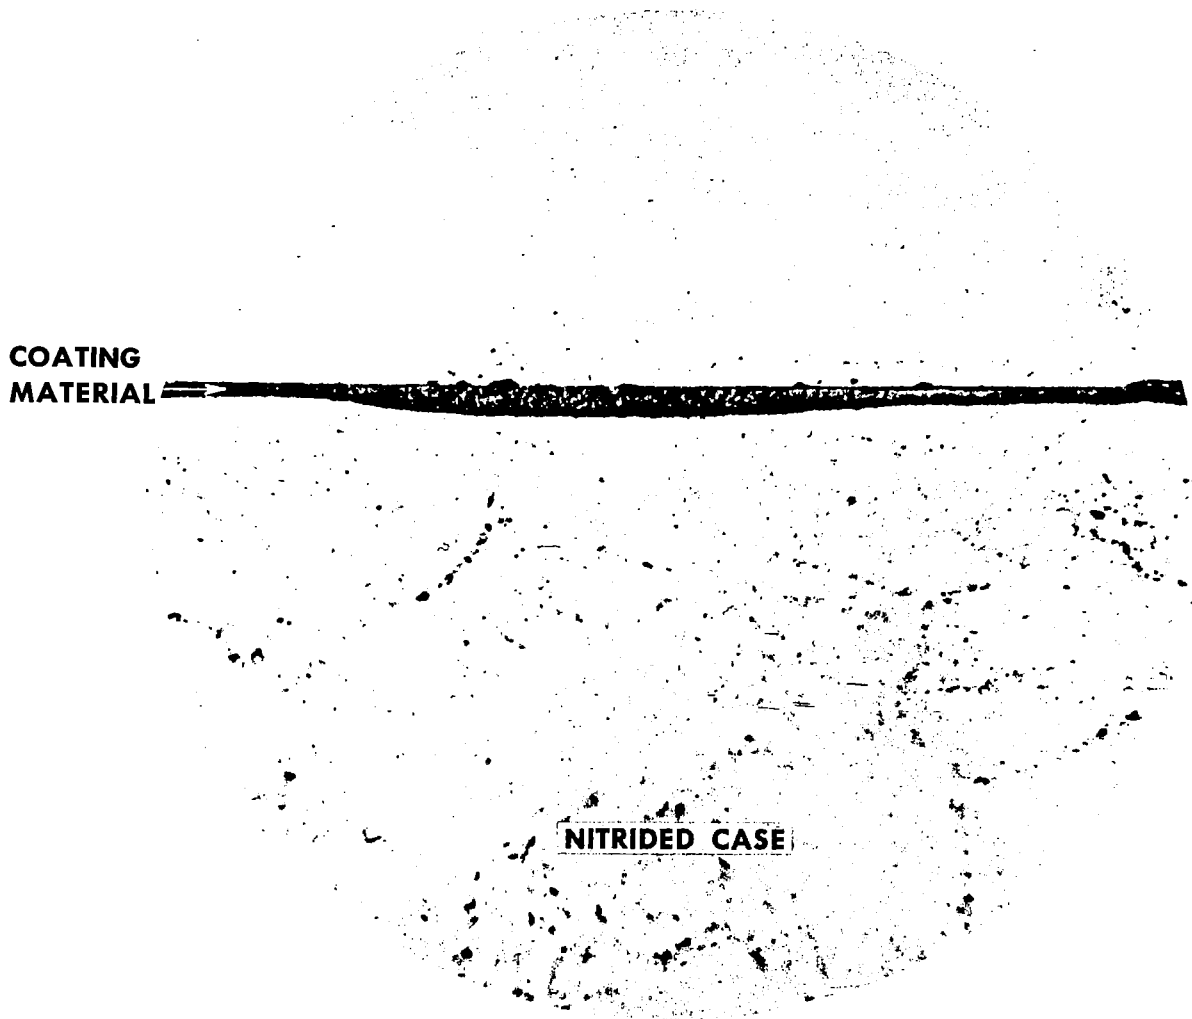
Figure 11.—Transverse section of the running face of a nitrided-steel piston ring after test, showing coating material. Only the coating material has been darkened, thus rendering it easily visible. Same area as figure 10. Etched in hot concentrated potassium hydroxide. $\times 1,500$.

The coating, as a rule, tended to fill hollows in the surface profile of the piston ring. (See fig. 11.) The distortion in a large field of view inherent in photomicrographs made at high magnification made difficult the determination of the relative heights of coating and basis material of the piston ring. The relative heights of the coating and the basis material were determined by light-interference methods. An optical flat placed next to the running face of the piston ring and illuminated by a sodium lamp produced the interference rings shown in figure 15. The distance between adjacent dark bands represents a difference of 0.0001 inch ($1/2$ wave length of sodium light) in the distances between the surface of the ring and that of the optical flat at the bands. In order to find the height of the material above the basis metal, it is only necessary to count the interference fringes between the top of the coating surface and an adjoining region of basis metal and to multiply by 0.0001. The coating in these tests was from 0.00001 to 0.00002 inch above the nominal surface of the particular specimen.

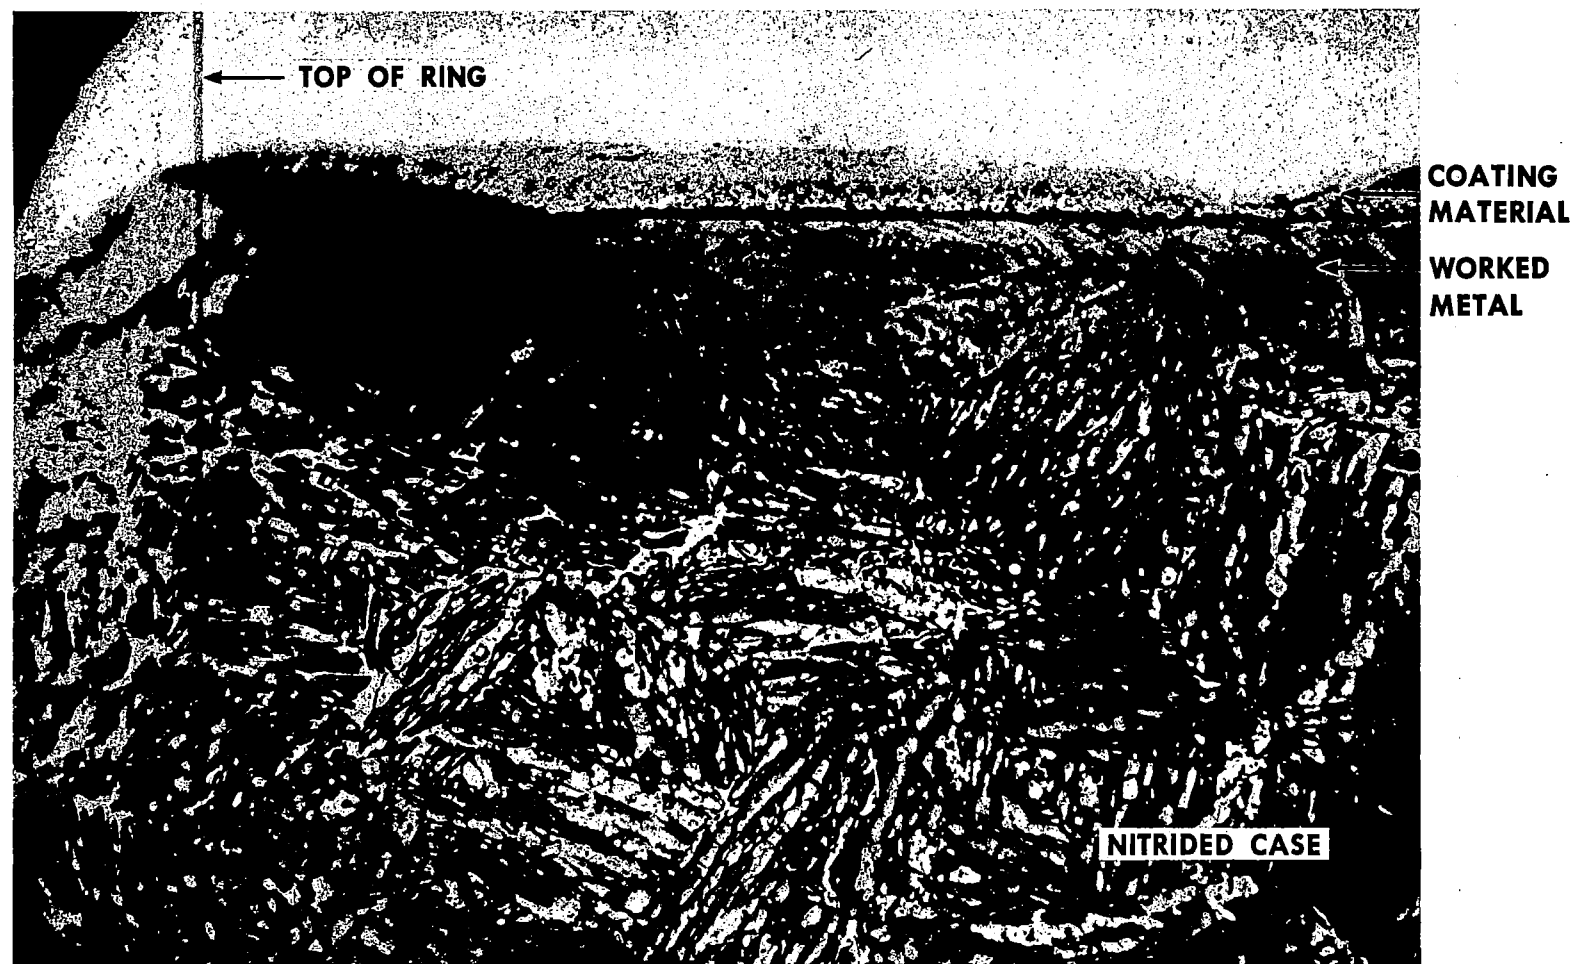
Figure 12.—Transverse section of the running face of a nitrided-steel piston ring after test. The coating material has formed a heavy layer over those parts of the face where no white nitride exists. This ring was used for two tests and then lapped. It was then run in for 1 hour and operated for 25 hours at 2,500 r. p. m. and a brake mean effective pressure of 209 pounds per square inch. Etched in nital. $\times 1,500$.

Evidence that the formation of the coating material is negligible in the portions of a ring where white nitrides are present is given in figure 12. The nitrided ring shown in this figure was run in a nitrided barrel and it can be seen that the white nitrides have formed little coating material. Figure 13 shows the portion of the ring immediately adjacent to the portion shown in figure 12 and it can be noted that, except for the white edge seen in figure 12, the coating layer is continuous.

The thickness of the coating (determined in every case by sectioning) was 0.0001 inch or less. Figure 14 illustrates a magnitude of thickness typical of most coating layers viewed. The chief exception to this thickness measurement is shown in figure 12 where the thickness of the layer has reached 0.00025 inch.

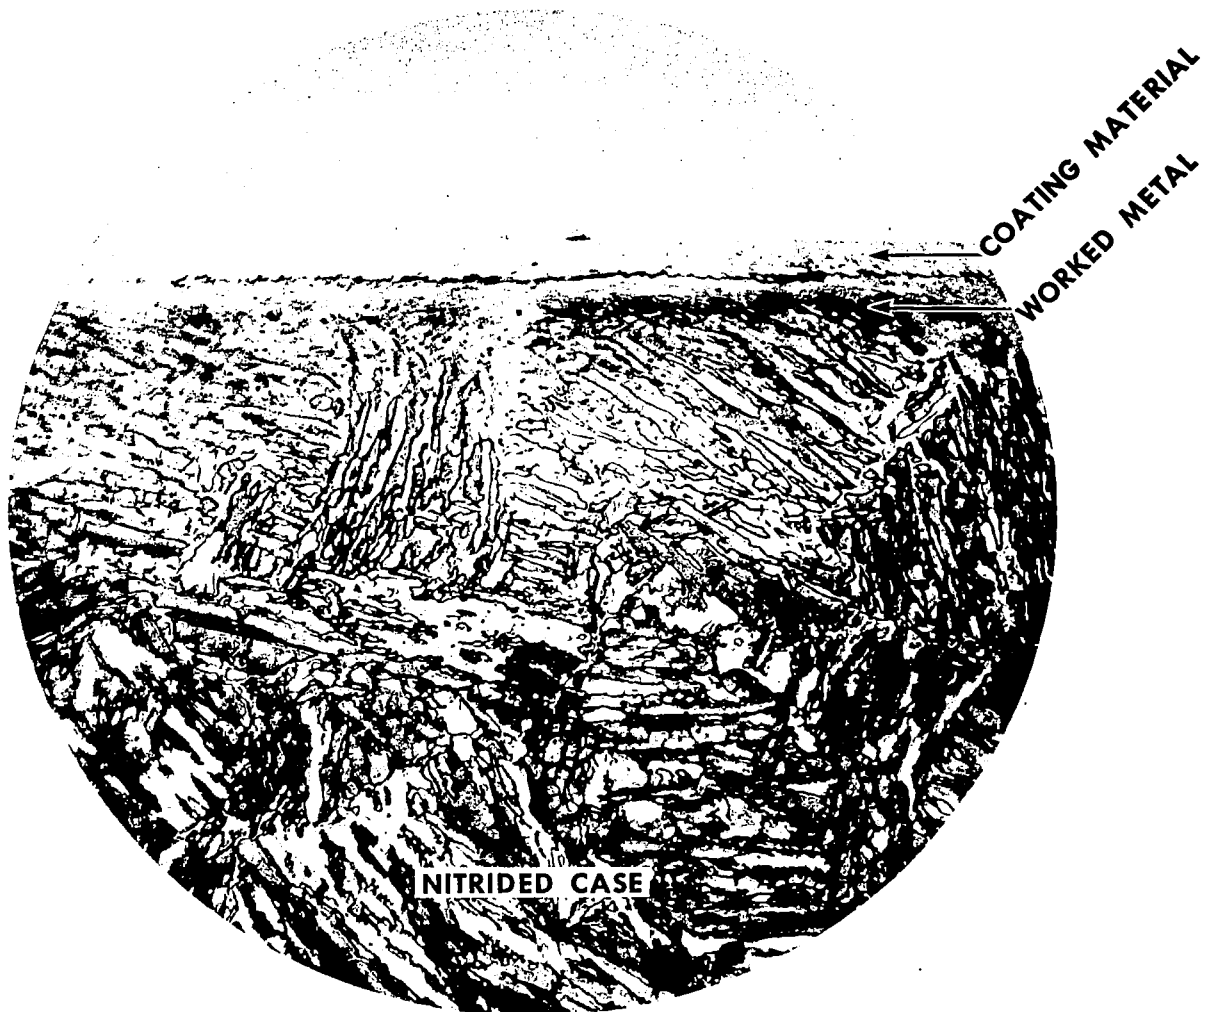
Figure 13.—Transverse section of the running face of a nitrided-steel piston ring after test, showing coating material. Same ring as figure 12. Etched in nital. $\times 1,500$.

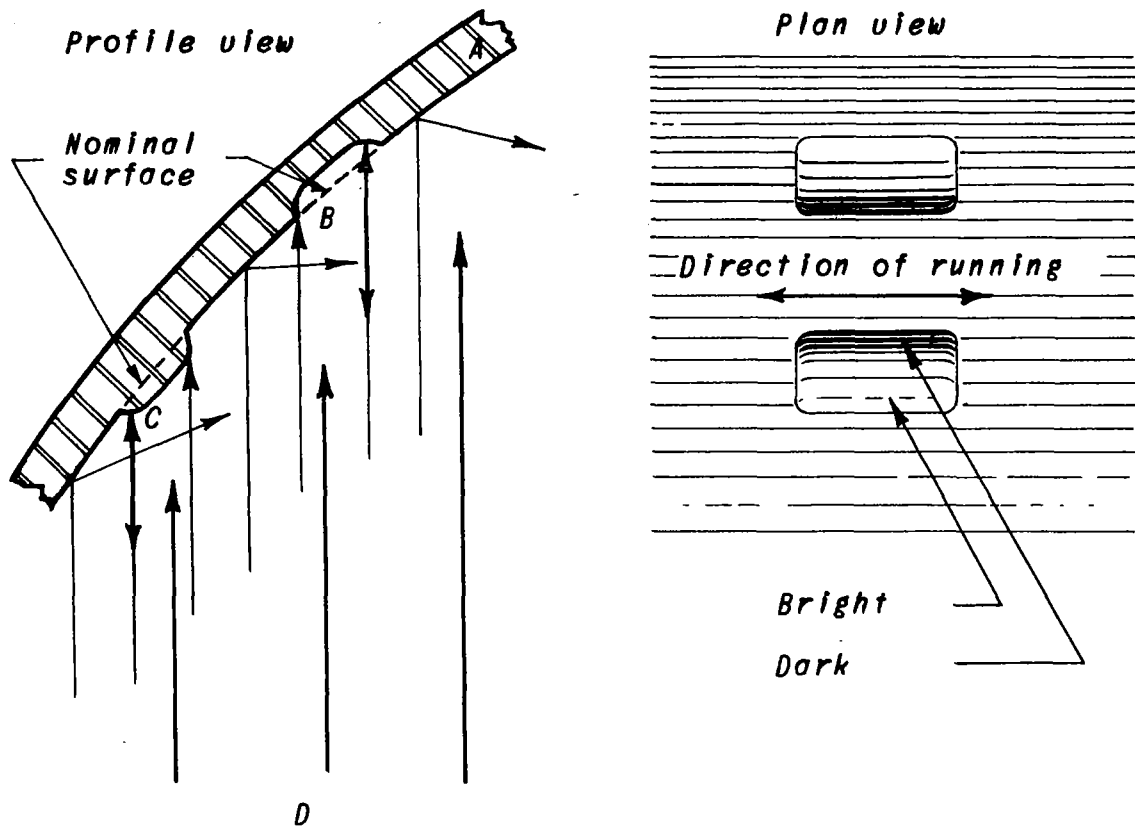
- A Cylinder-barrel specimen
- B Pit (Note that brightest reflection is on far side of light source.)
- C Build-up (Note that brightest reflection is on near side of light source.)
- D Light source and observer

Figure 16. - Geometry of light reflection.

The photomicrograph of coating material on a cylinder barrel (fig. 9) shows conclusively by light reflection that the coating was raised above the nominal cylinder surface. For convenience, the geometry of light reflection from the coating on a cylinder barrel is shown in figure 16. If the coating were to form as a build-up on the cylinder barrel, the bright sides of the build-up would face the source of illumination. If pits were formed, those parts of the pits away from the direction of illumination would become most brilliant. Figure 7, which is a photomicrograph of a nitrided-steel piston-ring face under oblique illumination, similarly, shows by light reflection that the coating material is slightly raised above the nominal surface of the piston-ring face.
